TECHNICAL SERVICE BULLETIN

Bulletin Nbr: 260-2538 Date:.....Mars 2005

Leakage from the coolant pump

Saab 9-5 M05 within Vehicle Identification Number range 53502502 - 53521624 with engine variant B235 and B205.

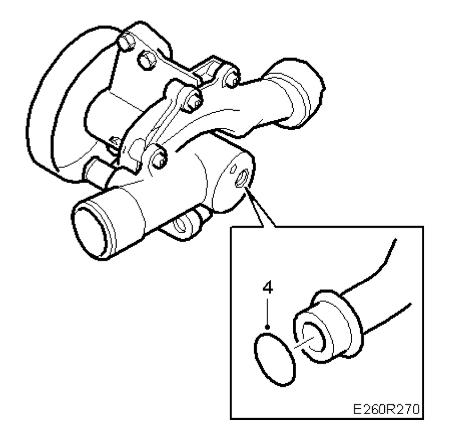
There have been instances where the O-ring on the coolant pipe to the coolant pump does not fully fulfil the technical requirements. In some cases this can result in leakage of coolant from the O-ring. In some cases the coolant pump has been replaced unnecessarily to rectify the leakage. It is the defective O-ring which should be replaced.

Fit both longitudinal coolant pipes to the coolant pump. Use the new O-ring, grease with Vaseline.

Tightening torque 10 Nm (7 lbf ft)
