The climate system has two air distribution flaps, one twin-flap for the driver's zone and the front seat passenger, and one for the rear seat passengers that is linked to the front flap. The two flaps are manoeuvred by a stepping motor fitted to the **passenger side of the heating and ventilation unit**. Consequently, the air distribution is common for the passenger and the driver zones. The air is distributed to the defroster, floor/rear door windows or the dashboard/rear centre vents.

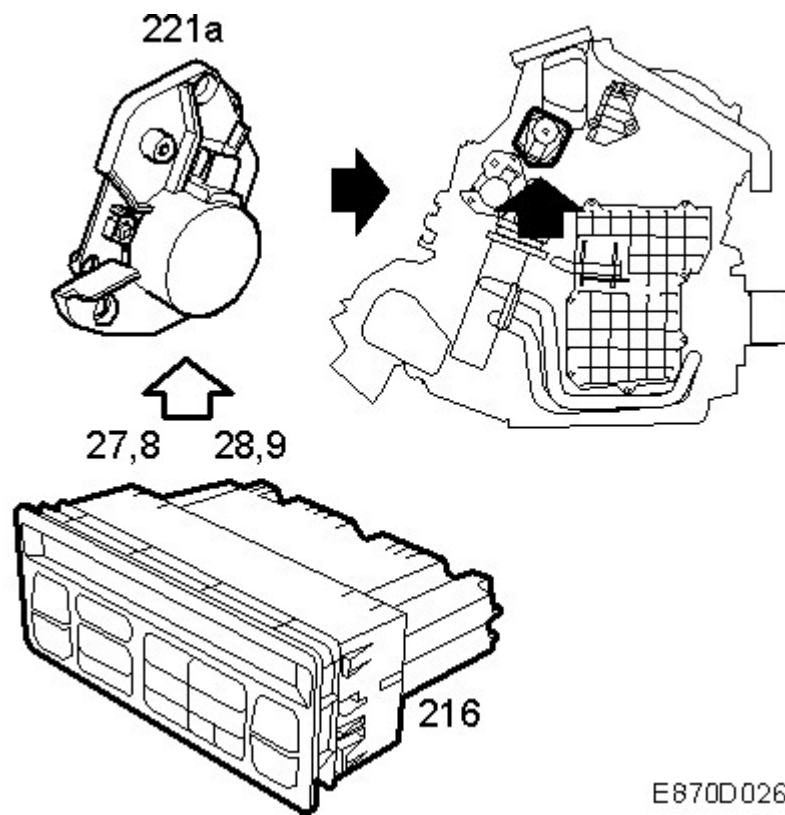
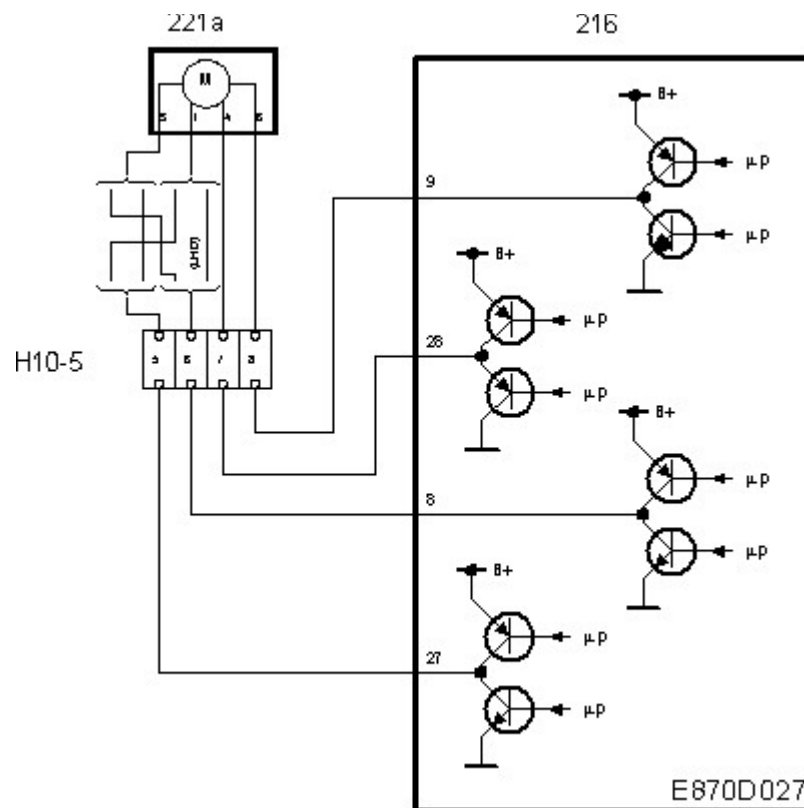
The stepping motor has two windings. The windings are energized in a special order with short pulses. This makes the motor move in short steps, which is how it got its name. The direction of rotation can be changed. When the motor is stationary, both the windings are energized continuously to lock the motor. The stepping motor does not require a feed-back coupling to the control module (position sensor). By sending a known number of pulses, the control module always knows how far the flap has moved. This is possible on condition that the control module has calibrated itself by turning the flap to its respective end positions so that it knows the position of the flap.

The stepping motor for the air distribution flap is supplied with current from the ACC unit pins 27 and 8 (winding 1) and pins 28 and 9 (winding 2).

Calibration is performed by pressing the AUTO and OFF buttons. Calibration must be performed if the battery has been disconnected/discharged, if the ACC unit or stepping motor has been changed, or if its position has been changed.

In the event of an open circuit or short circuit, diagnostic trouble code B2400 is set and 12 is displayed instead of right-hand temperature when calibrating.

If the motor jams, diagnostic trouble code B2406 is set and 13 is displayed instead of right-hand temperature when calibrating.

DTC B2405 will be generated if there is no mechanical connection between the motor and the flap, 14 will be shown instead of the right-hand temperature for calibration.

The diagnostics tool shows 100% in defrost position and 0% in panel position.
